Kashf inspection center (KASHF)Generated on 19 January, 2026 • Report #2316
, 2022Building No 356 - Street, 340 Salwa Rd, Doha, Qatar - Speed Marine Salwa
Main Showroom
97450666211

Fahsy Report

Car Make

2022

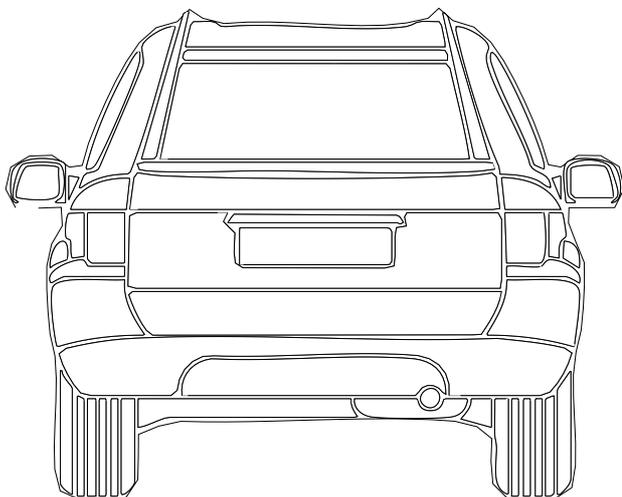
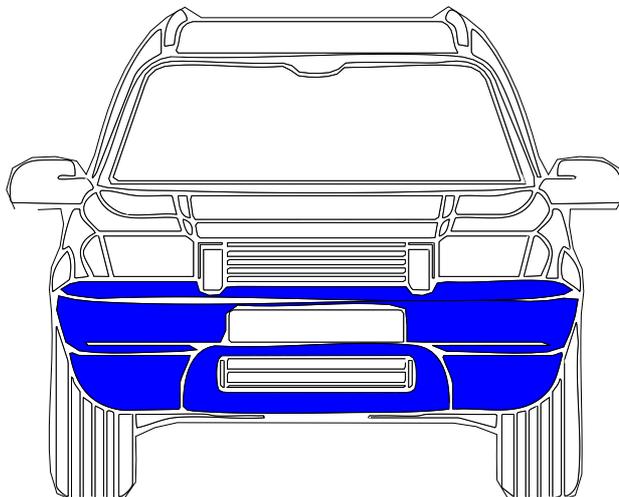
Body and berd

i Hood Bonnet	Good
• Hood bonnet repaint	
i front left fender	Good
• Front left fender repainted	
i front left door	Very Good
i rear left door	Very Good
i rear left fender	Very Good
i trunk door	Very Good
i Rear right fender	Very Good
i rear right door	Very Good
i front right door	Very Good
i front right fender	Good
• Front right fender repainted	
i roof	Very Good
i front bumper	Good
• Front bumper repainted	
i rear bumper	Very Good
i Front Windshield	Very Good
i Rear Windshield	Very Good

- Body dent scratch and body repaired body paint faded

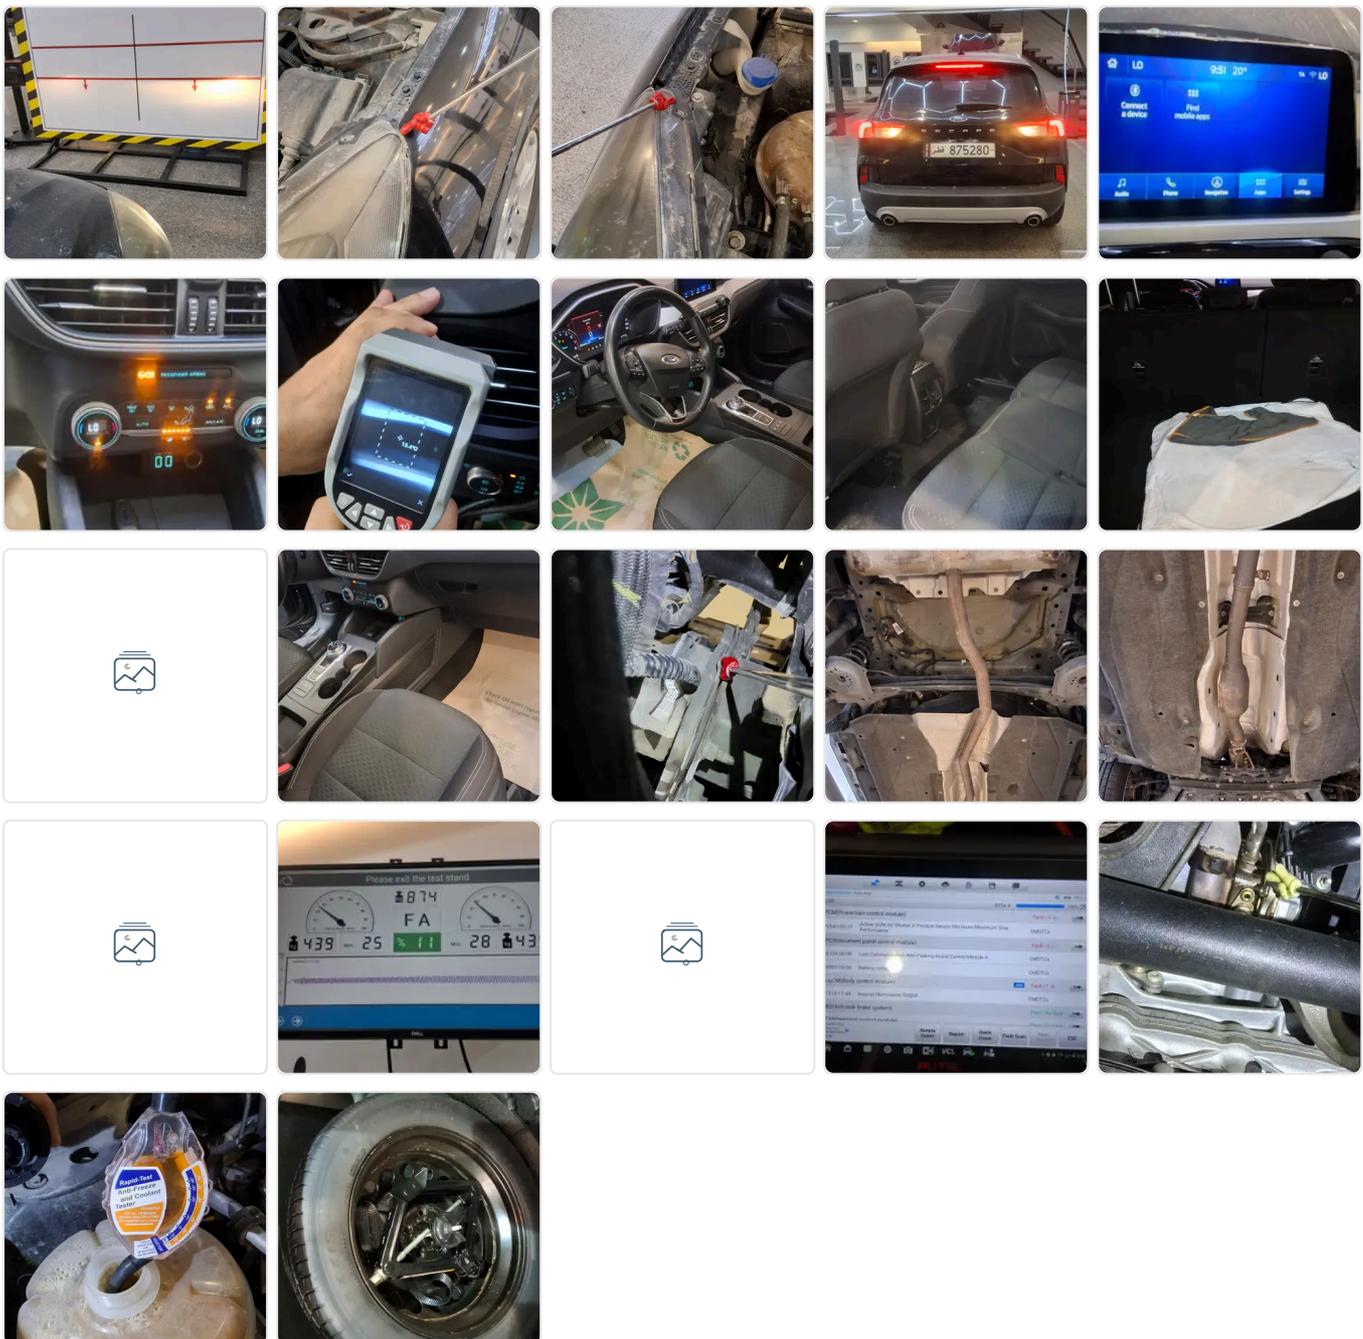
Inspection Images

- Left headlight not clear and both headlights broken
- Wiper water hose broken
- Hood bonnet repaint
- Front left fender repainted
- Front right fender repainted
- Front bumper repainted
- Body dent scratch and body repaired body paint faded
- Dent on front left head chassis
- Stone hits under the car and lower cover broken
- Front accident
- Timing cover open before & engine oil pan open before & valve cover open before engine-86%
- Air shutter grill malfunction
- Oil leakage from turbo
- Need to change coolant water
- Need to change rear tires
