## Golden Munich Cars Inspection W.L.L

Car : **MG ZS**

Type of Check : **Engine +gear+chassis+paint**

# Saicmg Vehicle Diagnostic Report

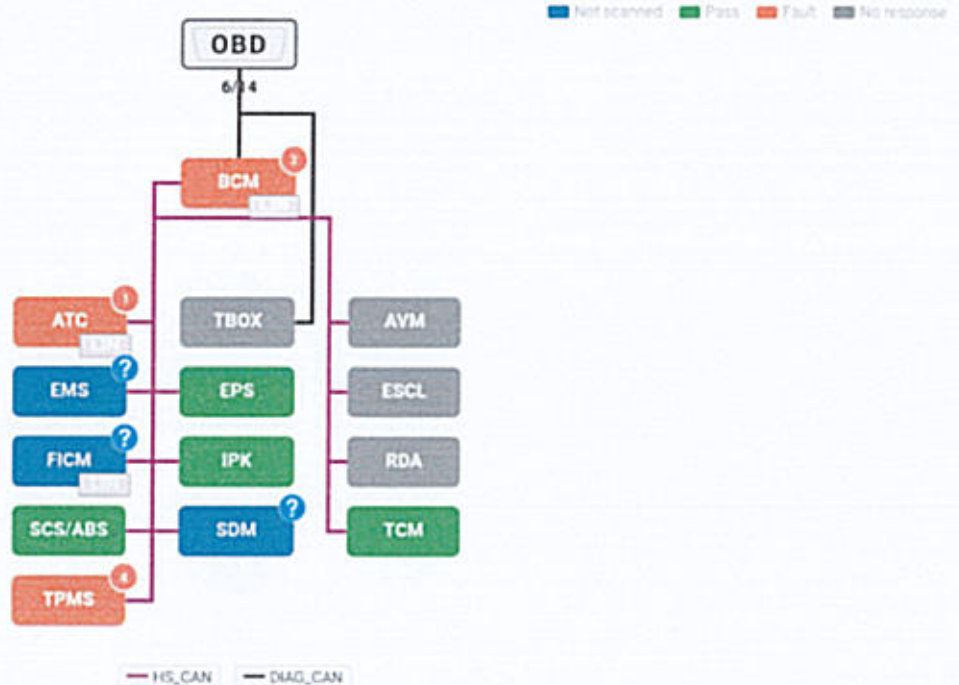
### Topology

| System | Status/DTC |
|---|---|
| TPMS (Tyre Pressure Monitoring System) | <span style="color: red;">✖</span> 4 |
| BCM (Body Control Module) | <span style="color: red;">✖</span> 2 |
| ATC (Automatic Temperature Control) | <span style="color: red;">✖</span> 1 |

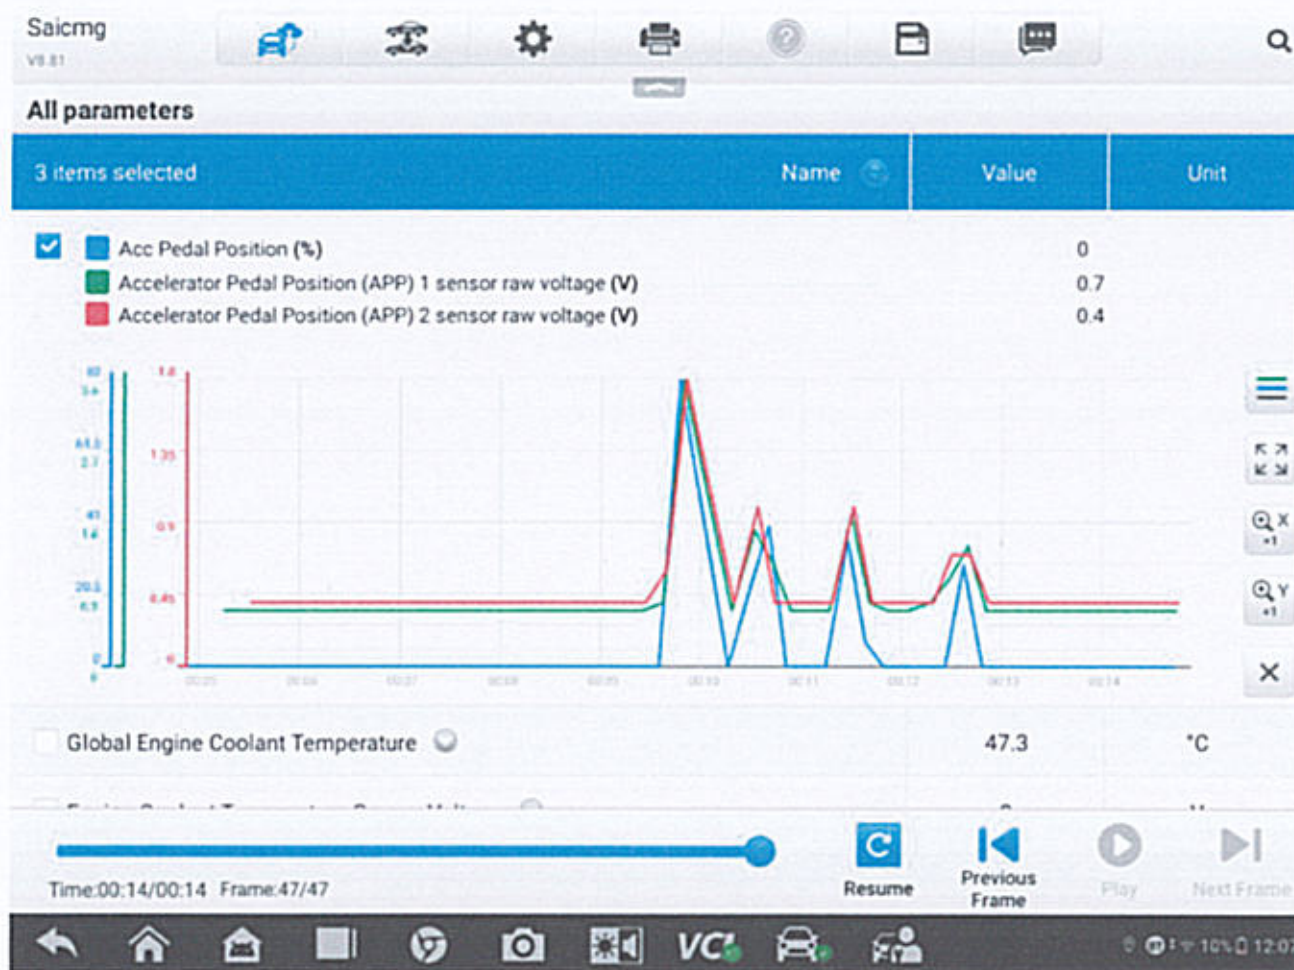
Saicmg/China/NEW MG ZS(2020)  
VIN: LSJW74U32PZ145160  
Path: Saicmg>Automatic selection>Auto scan>EMS (Engine Management System)>Live data

Engine: 93%
