Kashf inspection center (KASHF)

Generated on 14 August, 2025 • Report #984

Toyota Land Cruiser , 2006

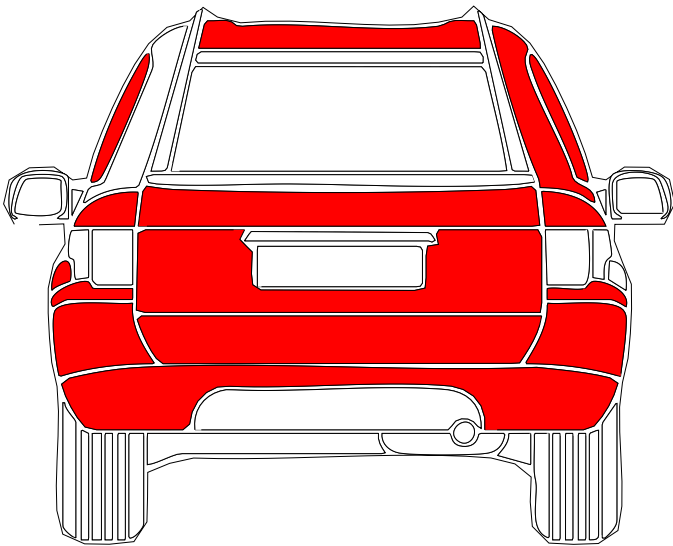
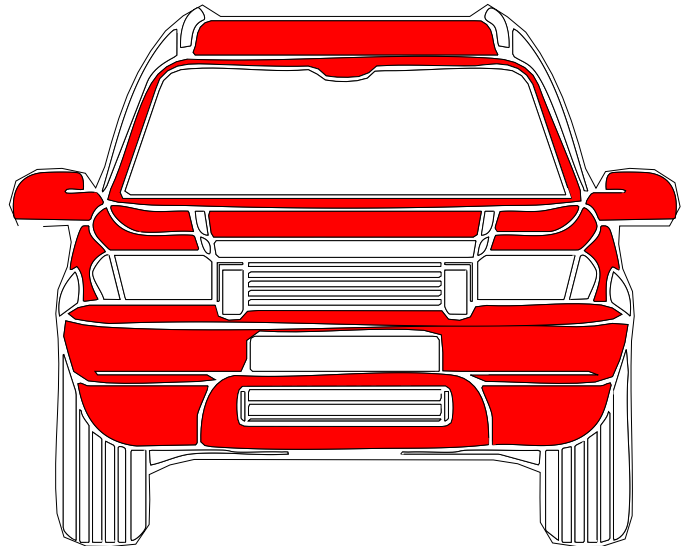
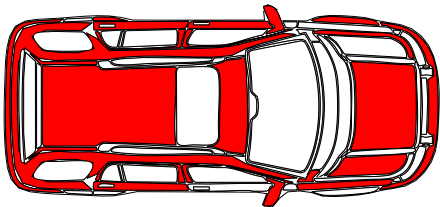
Body and berd

The chassis is fully inspected for 4*4

i Hood Bonnet	Very Good
• Minor dent in the engine cover and replacement	
i front left fender	Very Good
i front left door	Very Good
i rear left door	Very Good
i rear left fender	Very Good
i trunk door	Very Good
i Rear right fender	Very Good
i rear right door	Very Good
i front right door	Very Good
i front right fender	Very Good
i roof	Very Good
i front bumper	Very Good
i rear bumper	Very Good
i Front Windshield	Very Good
i Rear Windshield	Very Good
i Door Rubber	Very Good

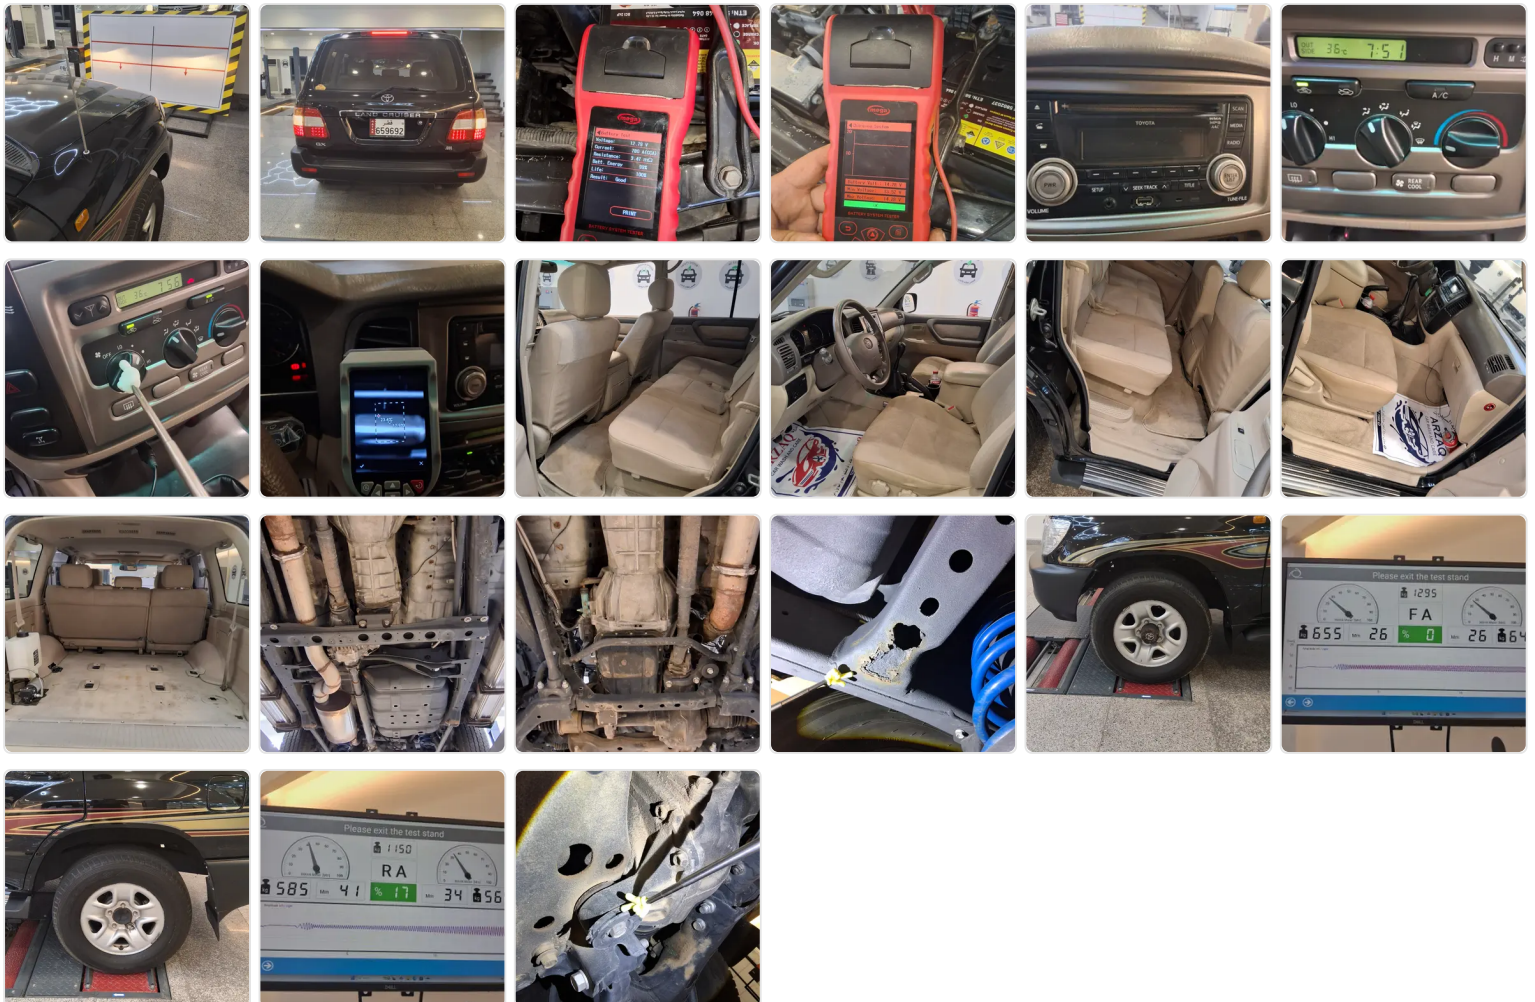
Inspection Images

- Malfunction in the power steering pump
- Minor dent in the engine cover and replacement
- Complete repaint Full protection on the entire vehicle External body dents
- There is a dent on the fender
- Front dent
- Rear dent
- Replacement of the front bumper
- Modified engine
- Spare tire not available
- The rim is modified / dented on the tires Malfunction in the rear tire
