## Golden Munich Cars Inspection W.L.L

Car : **PICANTO**

Model : **2022** Color : **WHITE**

# 2022 Kia(Europe) Vehicle Diagnostic Report

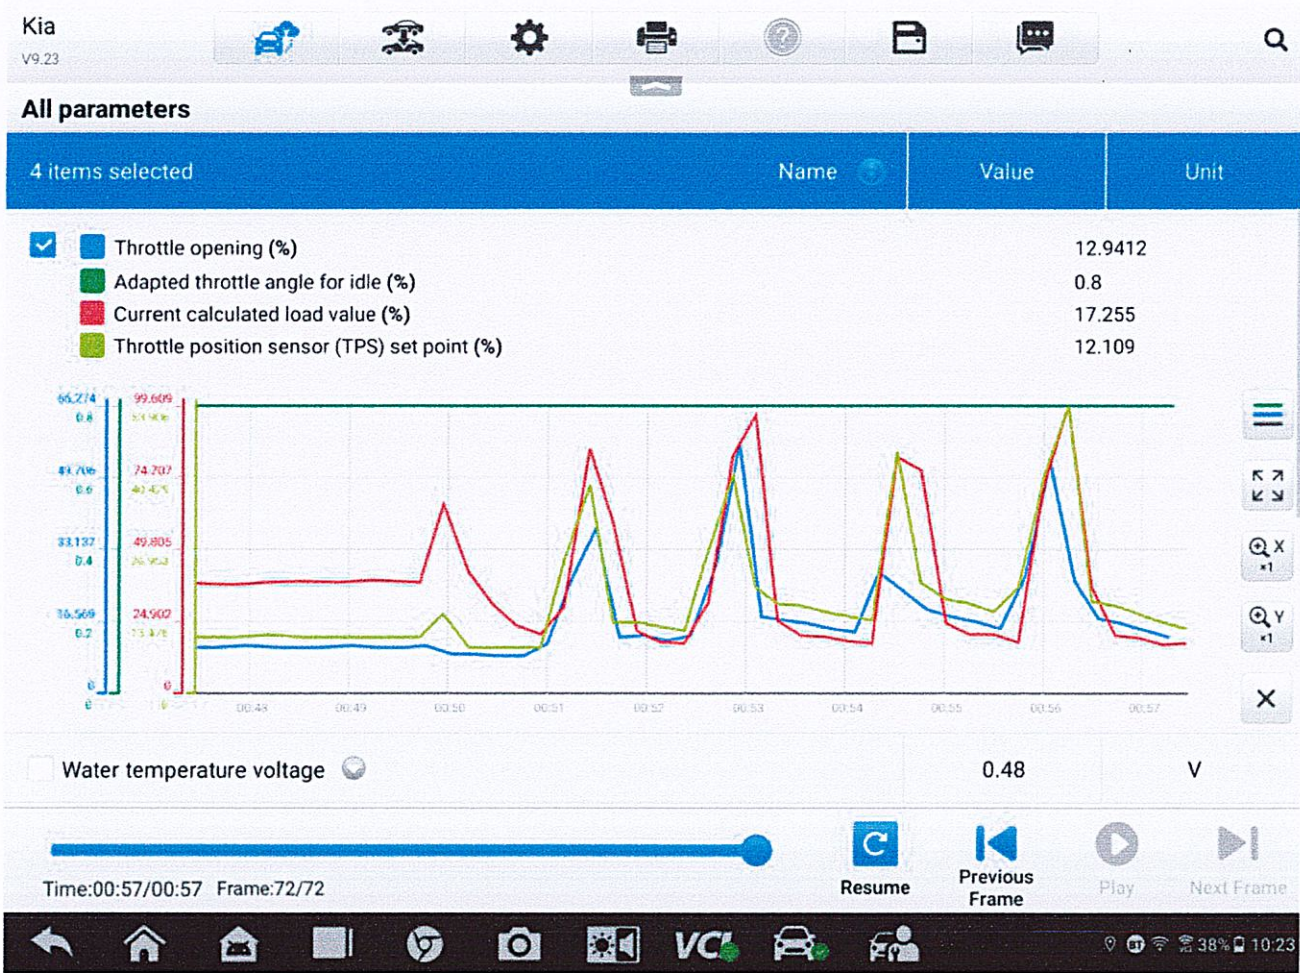
2022/Kia/Picanto/Morning (JA)/G 1.2 MPI KAPPA  
 VIN: KNAB25121NT979899  
 Path: Kia>Automatic selection>Auto scan>ENG (Engine)>Live data

Engine: 90%.
