Golden Munich Cars Inspection W.L.L

Type of Check : Engine + gear + chassis + paint

## 2022 MAXUS Vehicle Diagnostic Report

2022/MAXUS/V80/V80 PLUS/  
VIN: LSKG5GC11NA068607Odometer Reading: 84926km  
License Plate: --

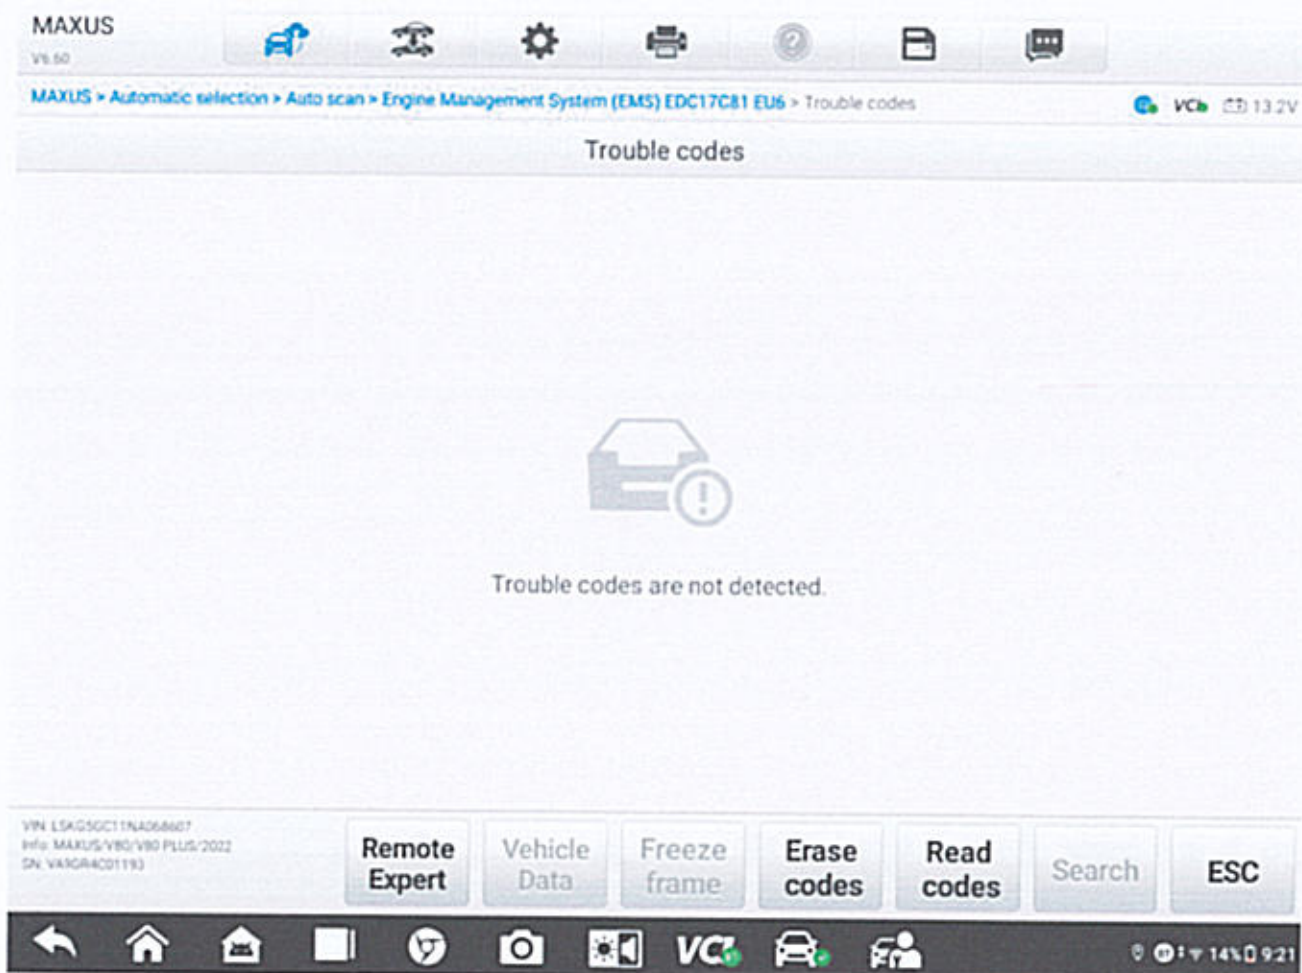
Path: MAXUS>Automatic selection>V80/V80 PLUS>Auto scan>Engine Management System (EMS) EDC17C81 EU6>Trouble codes

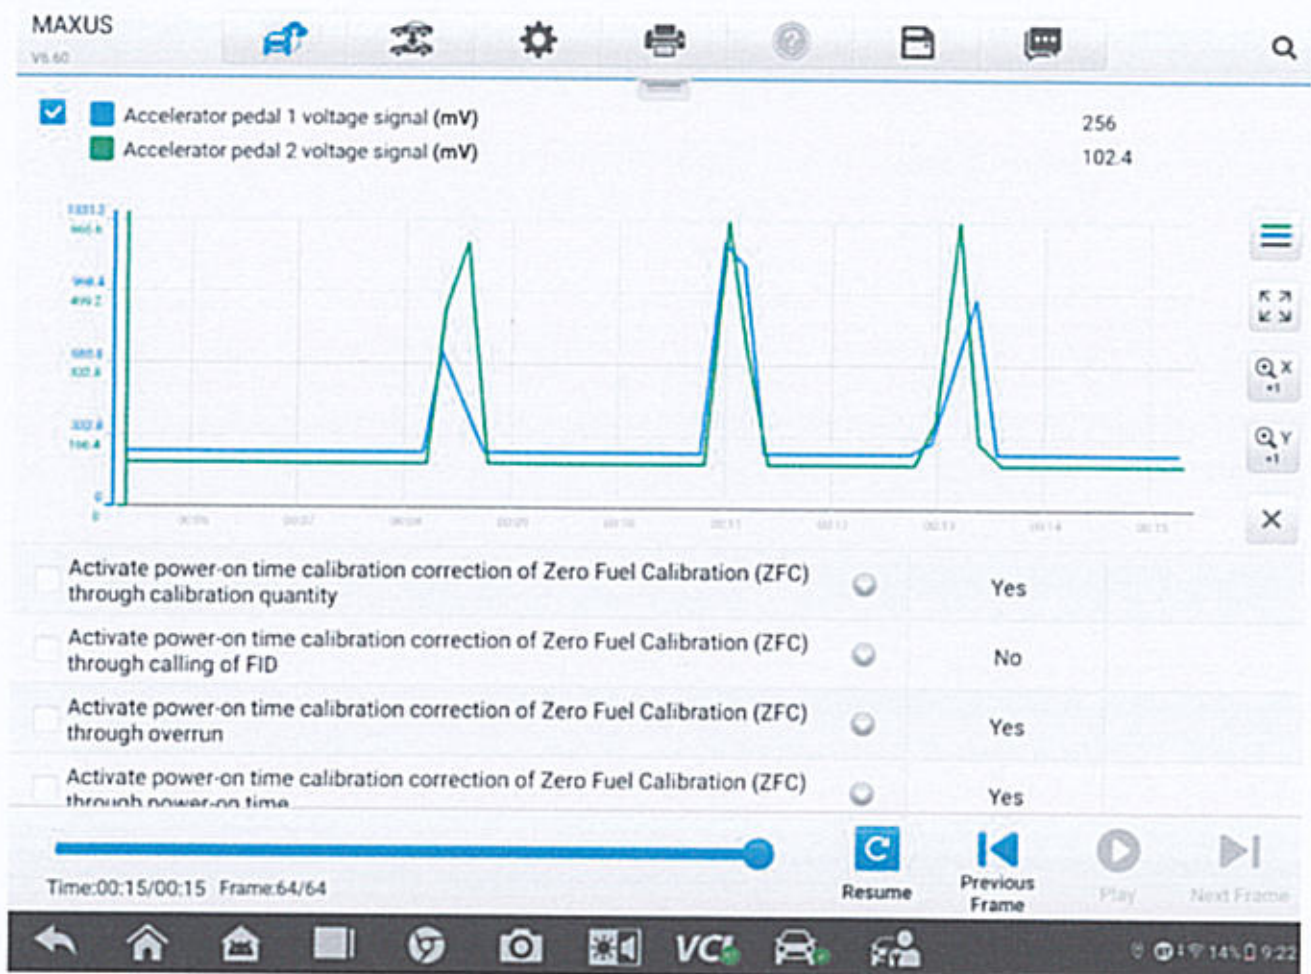
2022/MAXUS/V80/V80 PLUS  
VIN: LSKG5GC11NA068607  
Path: MAXUS>Automatic selection>V80/V80 PLUS>Auto scan>Engine Management System (EMS) EDC17C81 EU6>Live data

Engine 90 %
